TECHNISCHE UNIVERSITÄT MÜNCHEN

Report No. 2466 of 19th of September 2008

**Investigation on
FFU synthetic wood sleeper**

(Komat GmbH, Austria)

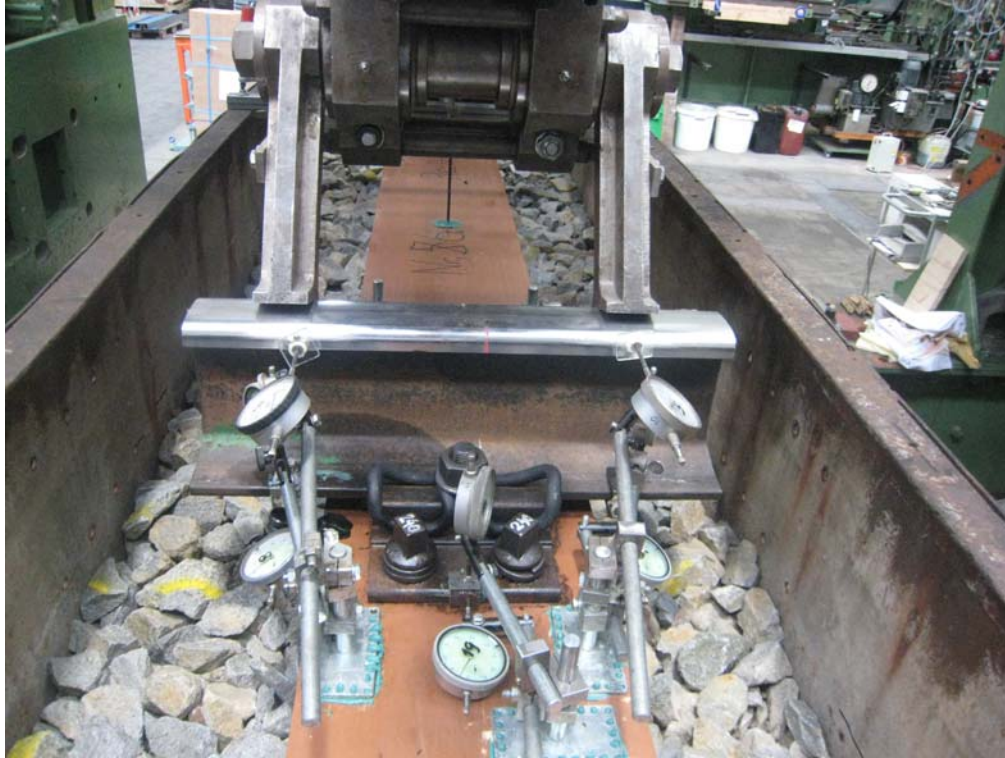
Repeated load test (fatigue test) in accordance with DIN EN 13230-3

The test setup is in accordance to figure 3b of DIN EN 13146-4 (see pictures in attachment 1.1).

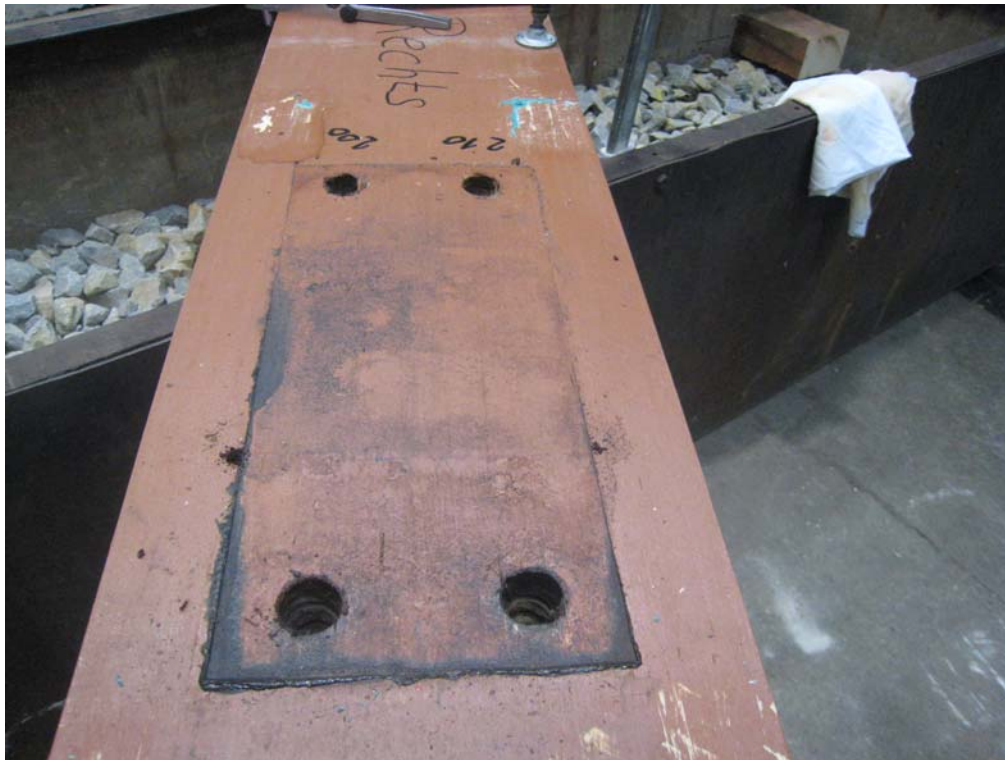
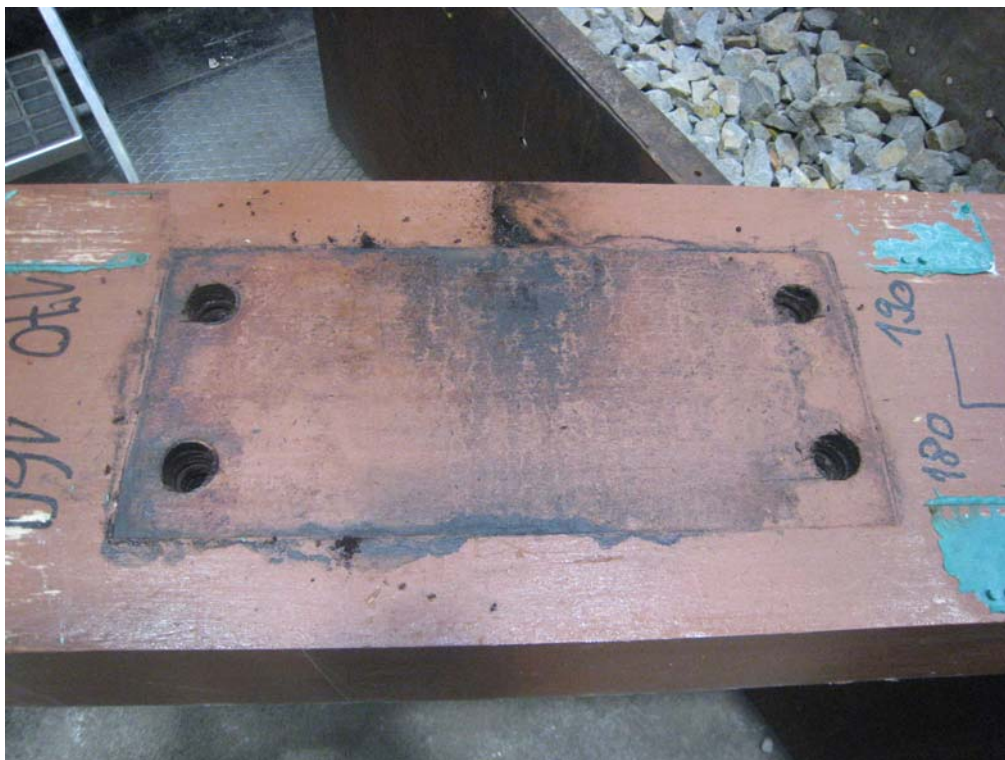
Permanent deformation of 0.3 to 0.7 mm on the sleeper surface after fatigue test (3.0 Million + 1.28 Million load cycles).

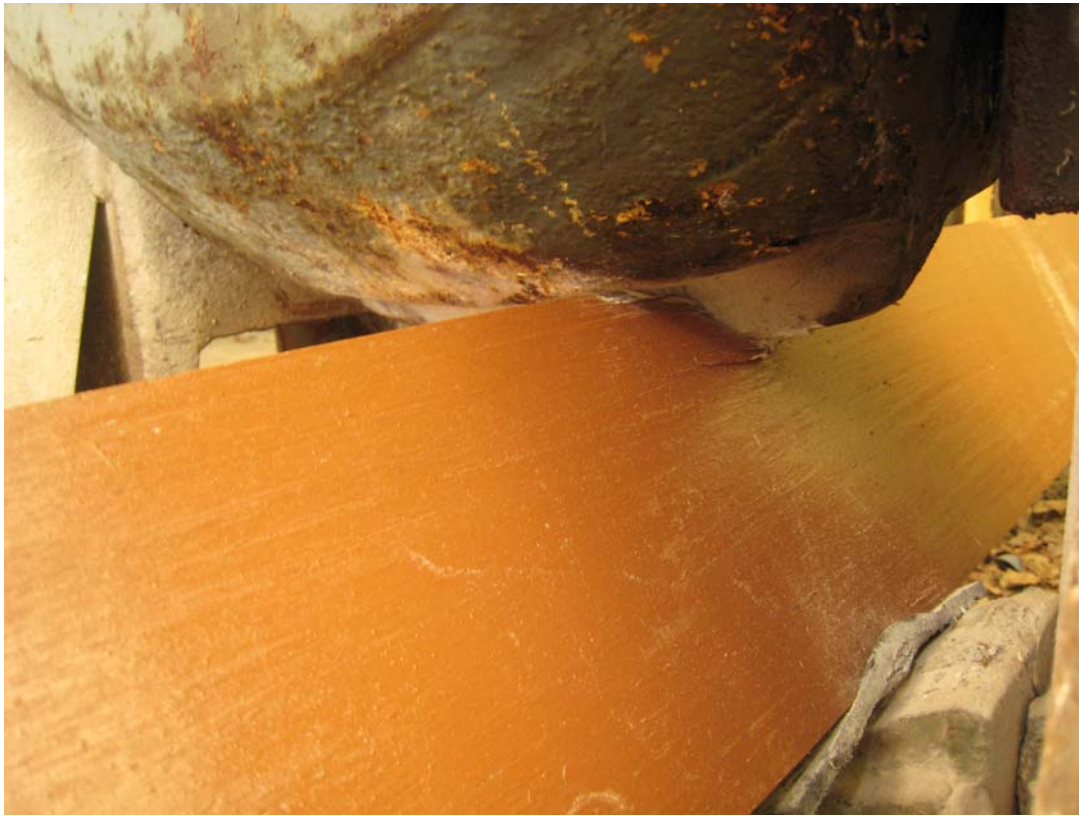
The tup with a wheel-flange shaped blade penetrates into the sleeper edge in a proper way. The damage is limited to a small area near impact position.

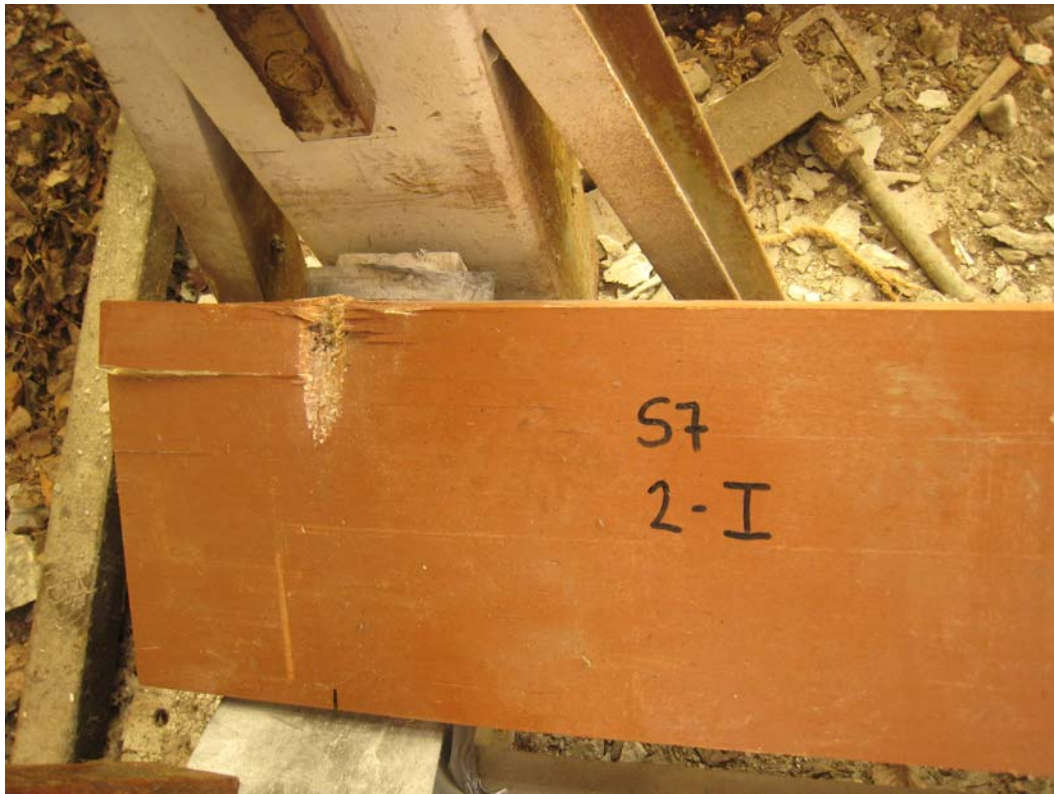
By derailment test II (impact on fieldside of the rail, 15 cm distance from sleeper front end) a wedge-shaped cutout is removed from the sleeper.

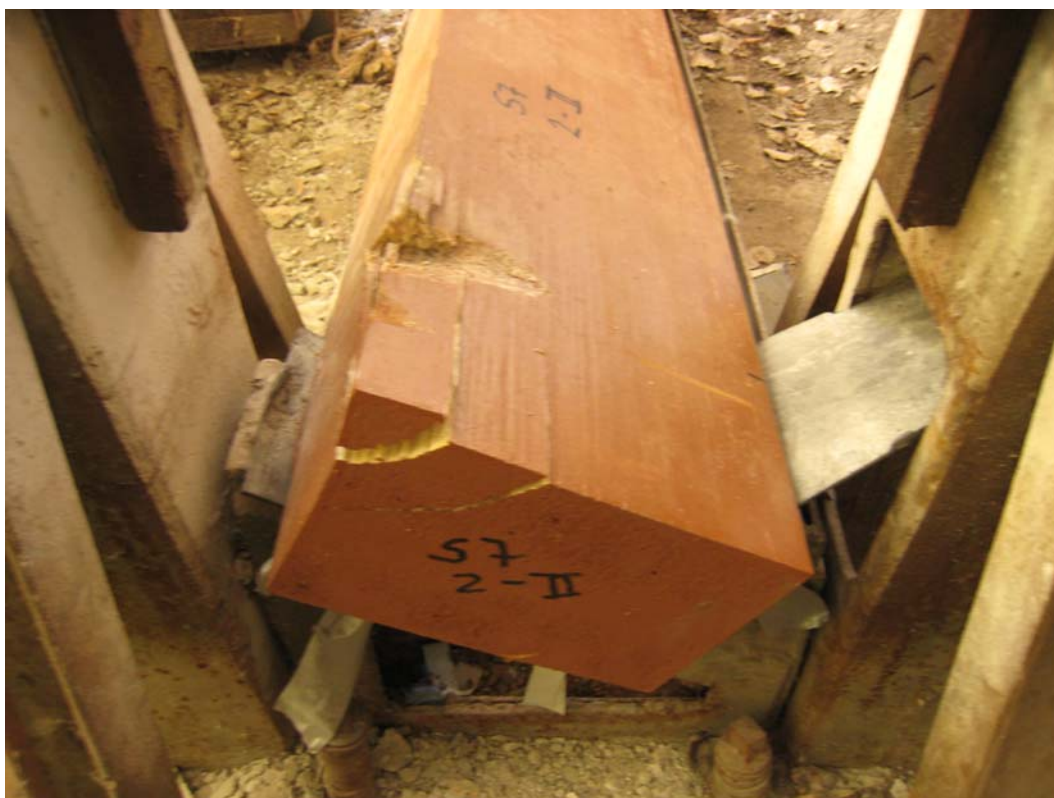
Wedge-shaped cutout after second impact in derailment test II.

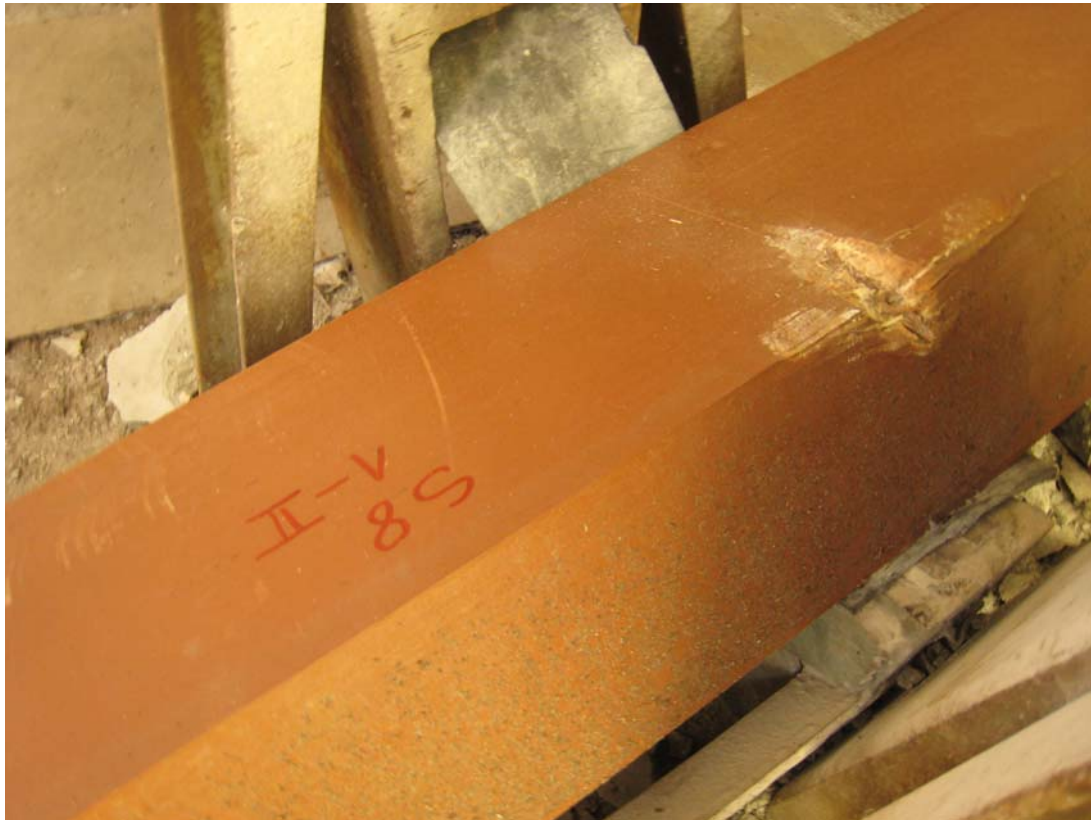
View of sleeper S8 after the second impact in derailment test I.

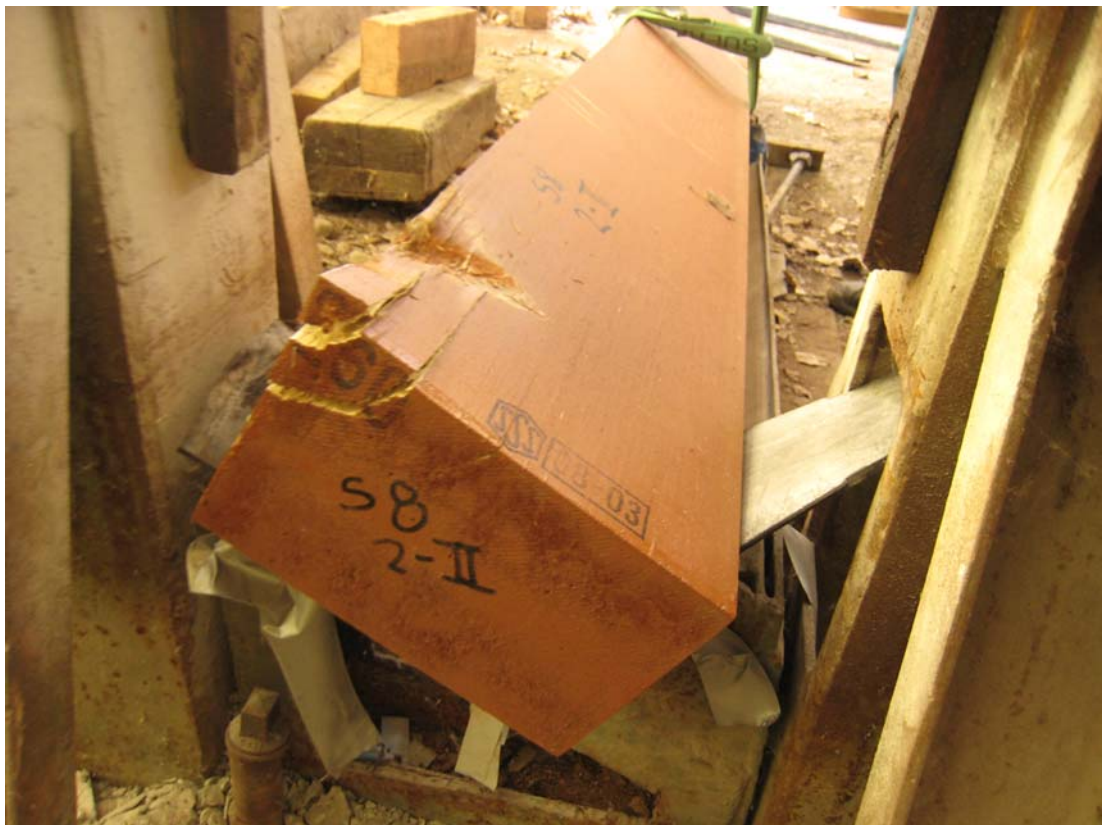
Wedge-shaped cutout of sleeper S8 derailment test II.

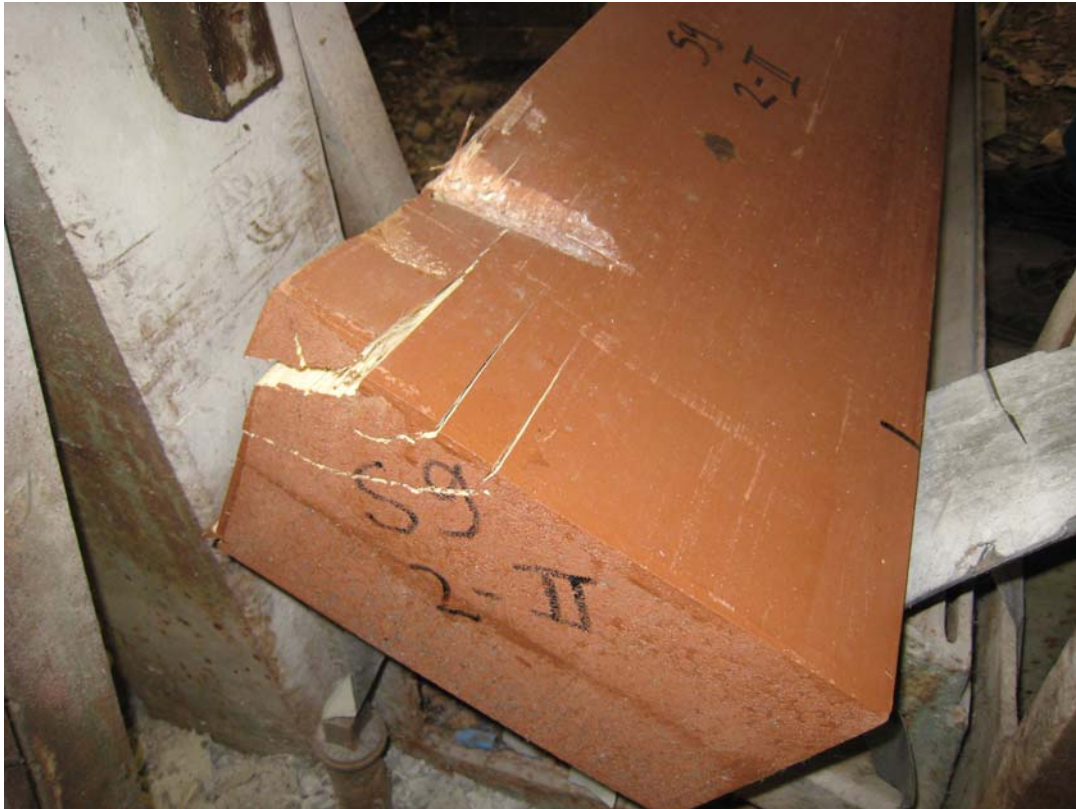
Caused by the homogeneous structure of the synthetic sleeper the derailment test shows clear and reproducible results.

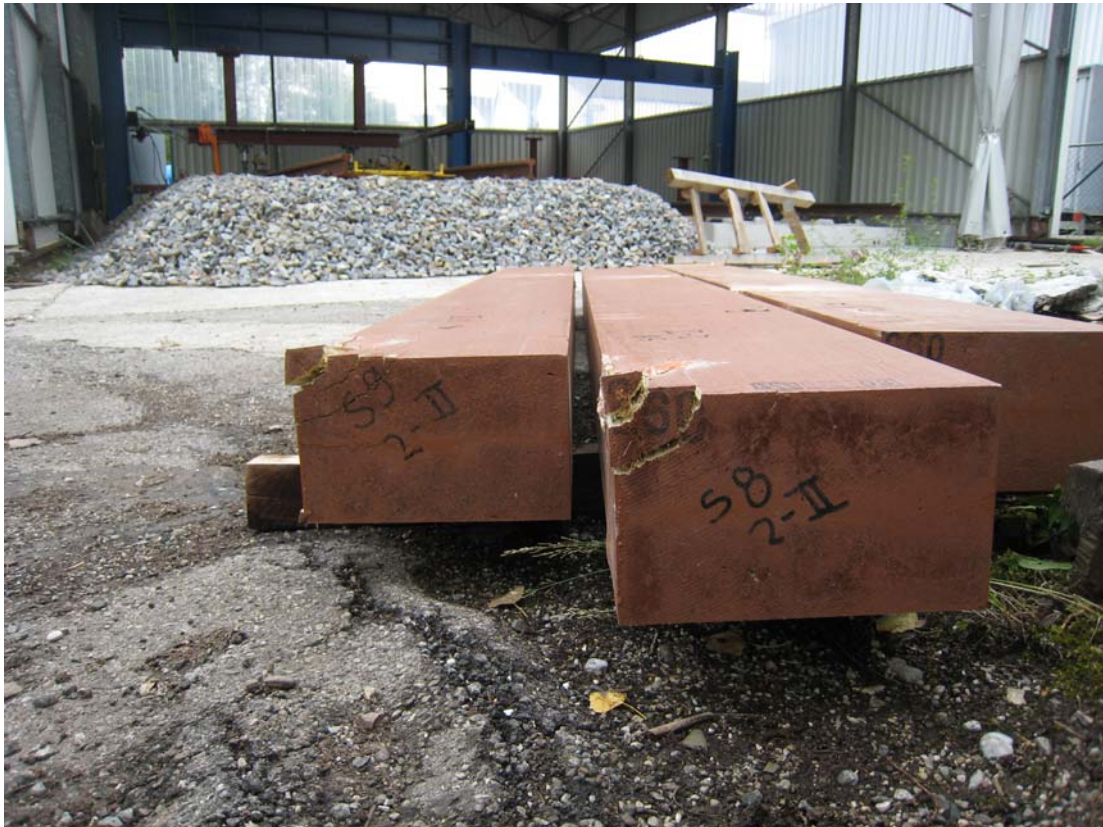
The synthetic sleepers do not show any warping after the derailment test.

Prior to and after each applied impact, each sleeper was checked for deformation with a graduated measuring rod. A change in track gauge (test criterion) can solely occur as a consequence of permanent sleeper deformation. The sleepers did not show any rotation or warping. Thus, track gauge remained constant.

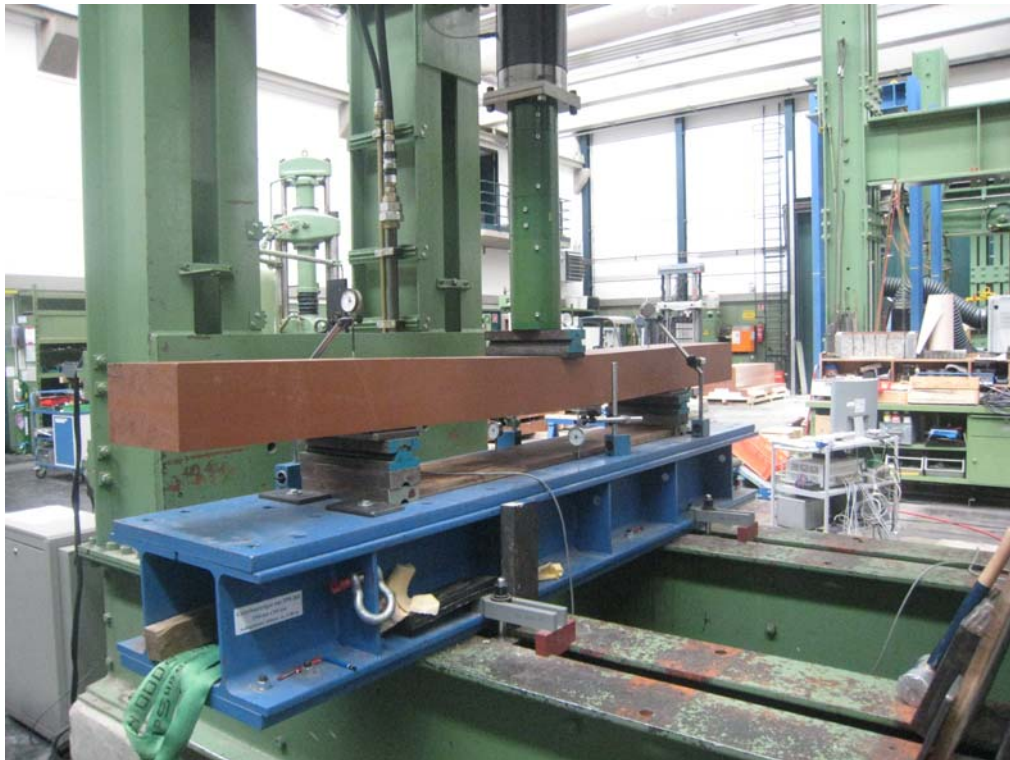
Synthetic wood sleeper

Static test in sleeper centre

Up to a load of 240 kN, corresponding to a bending tensile strength of 74 N/mm² on the bottom of the sleeper, no crack was detected within the bending tensile area. Strong plastic deformations and superficial fissures were detected within the bending pressure area (upper side of the sleeper), although it must be noted that generally, deformations of this scope do not occur in service.

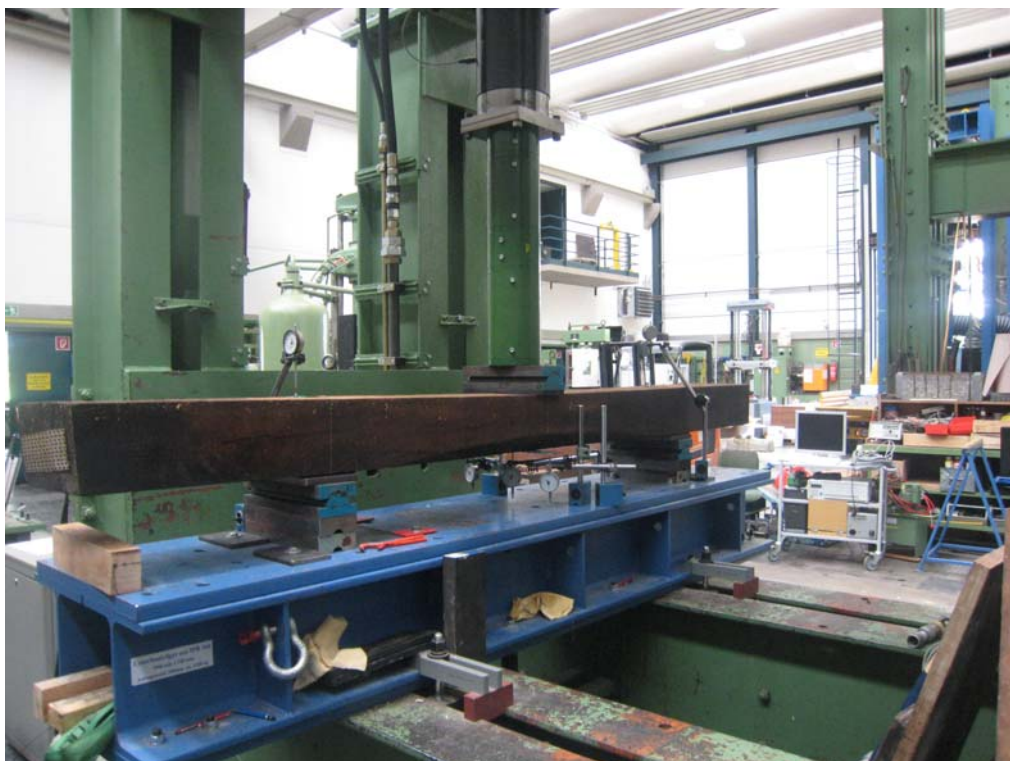
Wooden sleeper

The same test (265 mm x 160 mm) was conducted concurrently with a wooden sleeper (beechwood 265 mm x 160 mm). Please see results in appendix 5. According to the test results, the wooden sleeper failed at a load of 80 kN within the bending tensile area.

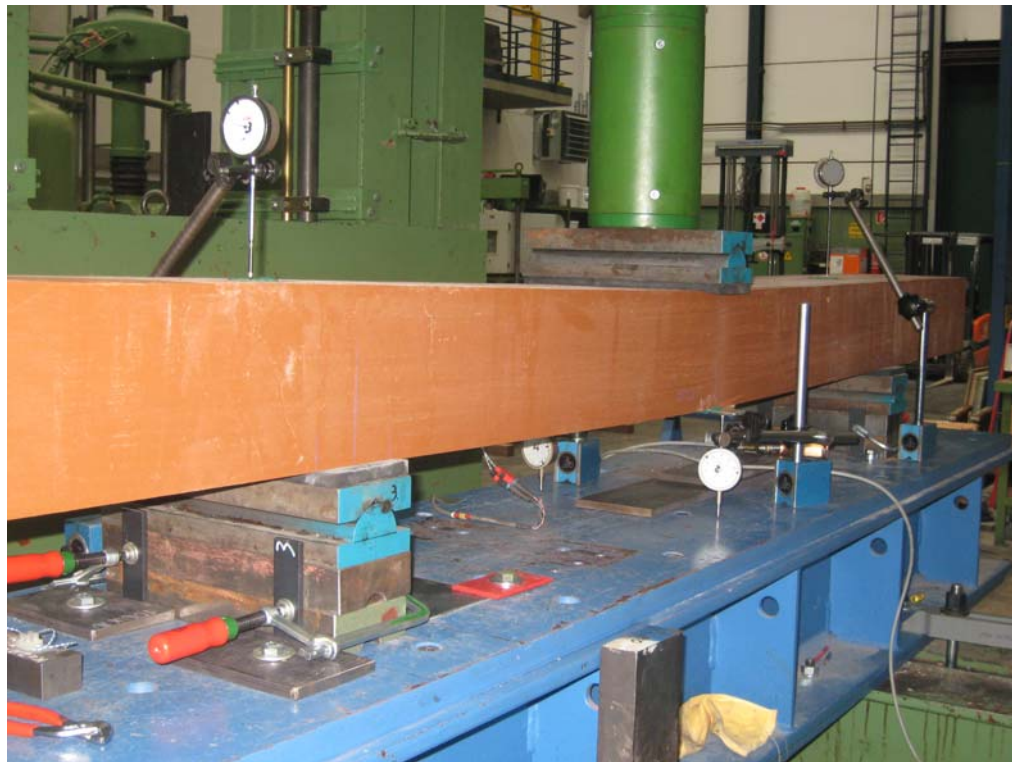
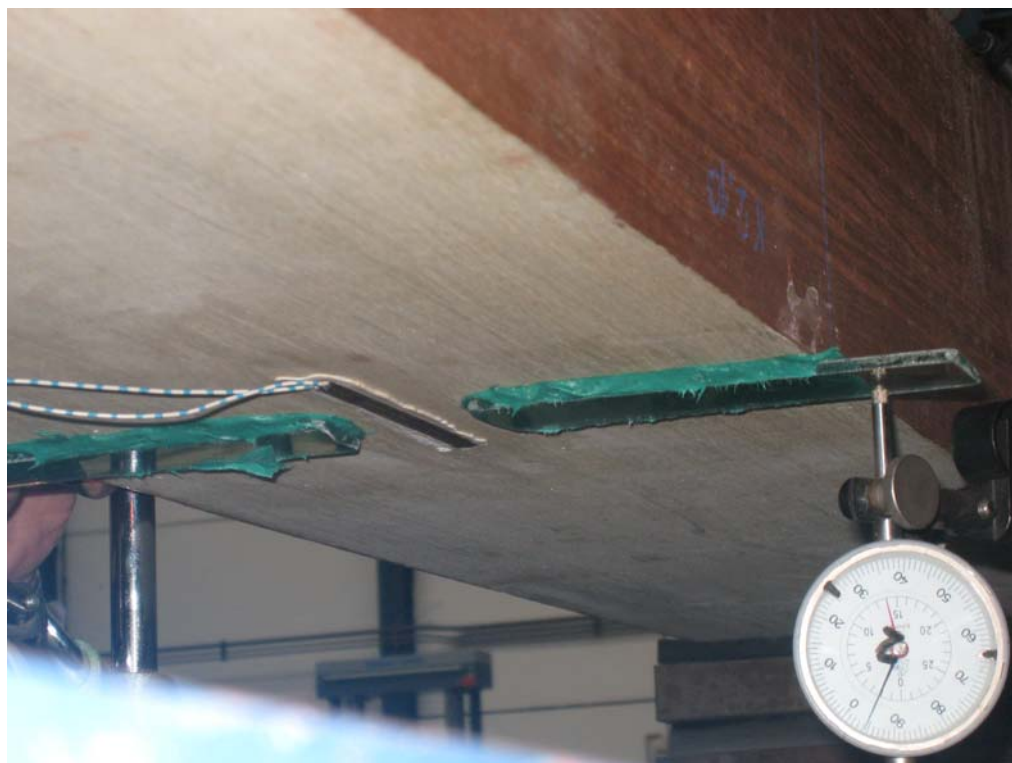
Fatigue test in sleeper centre

In order to investigate the behaviour of the synthetic sleeper under repeated load, a fatigue test according to DIN EN 13230-4 was conducted. Please see the picture in attachment 5 for the test setup. During the entire testing procedure, sleeper bending and strain on the bottom side of the sleeper in the area of maximum torque moment were registered.

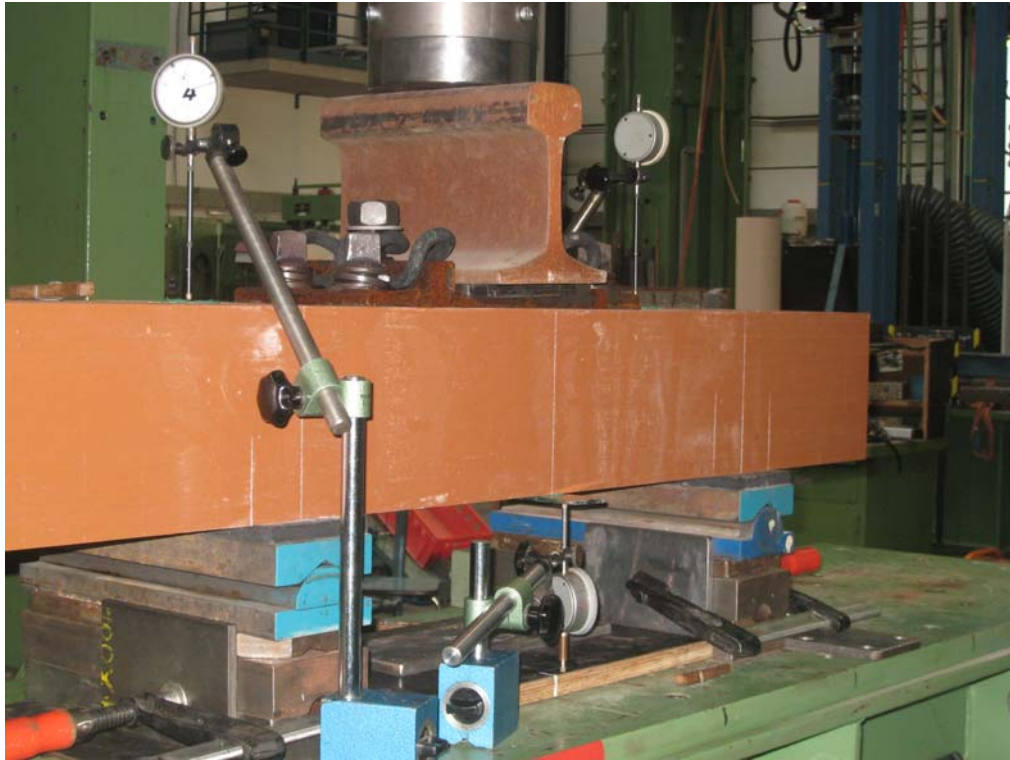
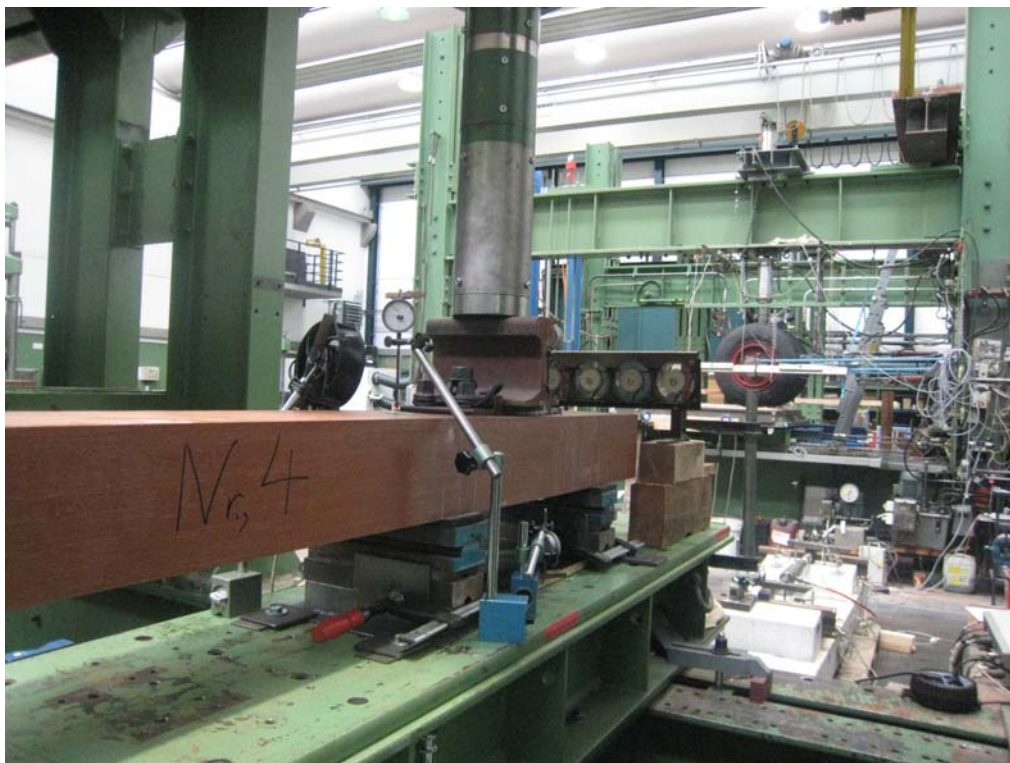
Fatigue test under rail seat

Please see attachment 6 for a photo of the test setup. The test was conducted under the following basic conditions:

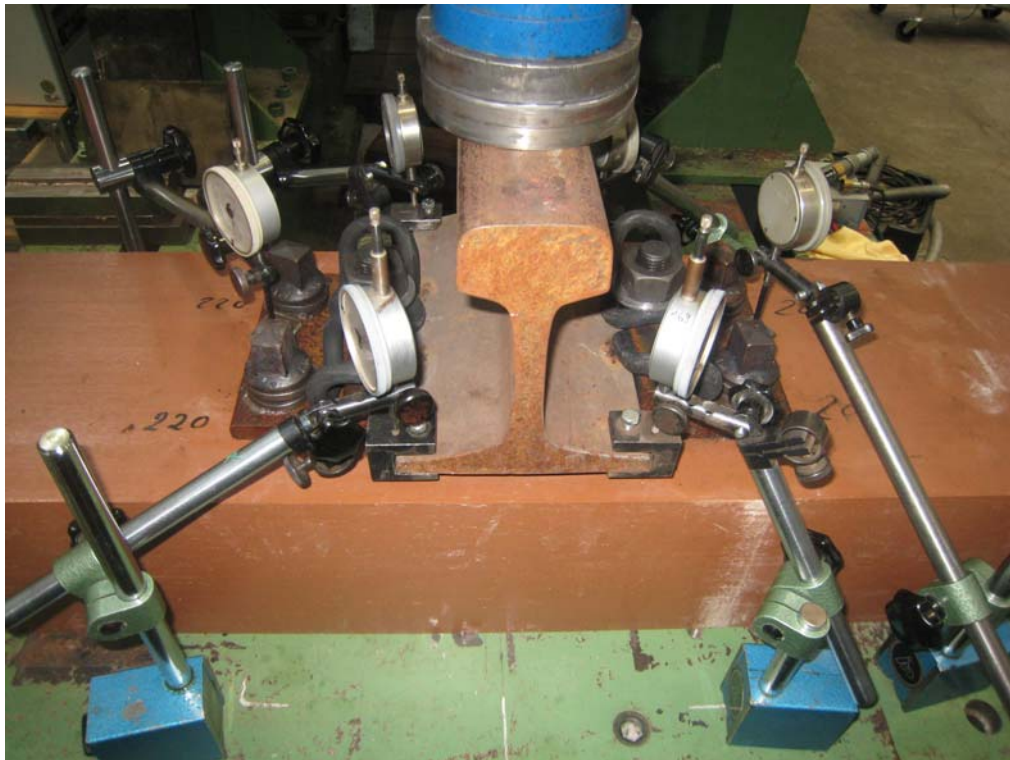
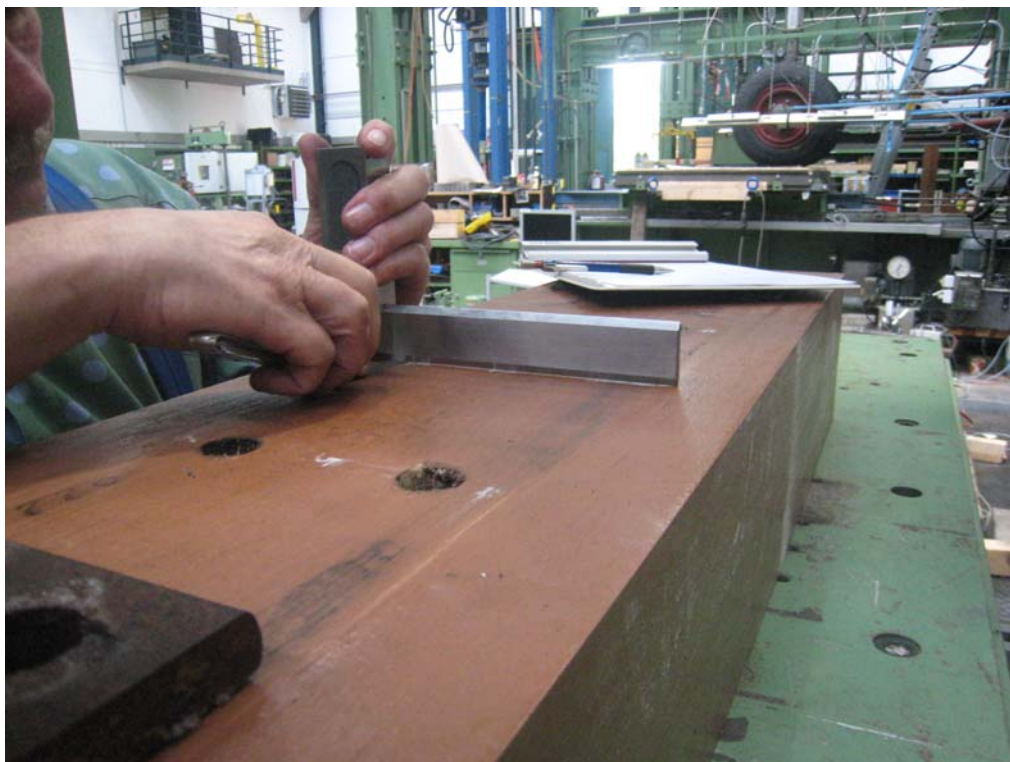
Static compression test (see chapter 2.9)

Thus, a load of 300 kN (on one rail seat) causes permanent deformation of a maximum of 0.8 mm below the base plate (see photos in attachment 7). As pointed out in 2.8, the load on one rail seat by an axle load of 250 kN is 150 kN in case of most severe conditions.
